Airworthiness Directive

AD 50-25-01

Airworthiness Directives; STINSON Model All Model 108 Series Aircraft

50-25-01 STINSON: Applies to All Model 108 Series Aircraft.

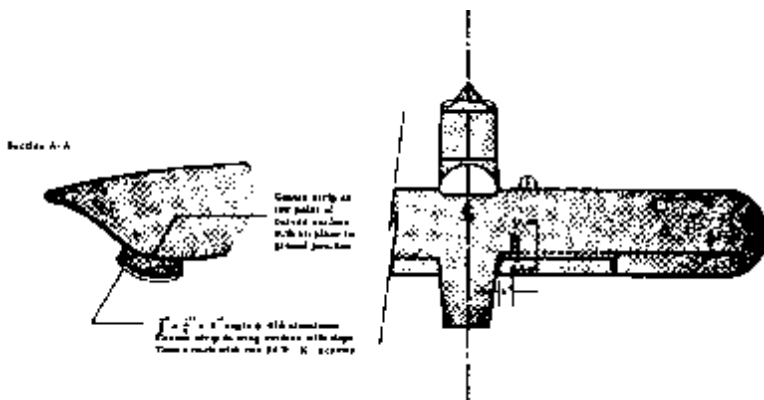
Reports have been received of fuel seepage into the space between the inner cabin trim and the outer fabric covering of the fuselage. This results in soaking of insulating material in the cabin wall.

The source of the fuel can be spillage during filling of tanks, thermal expansion of fuel in full tanks, or tank leakage. This fuel runs to the under surface of the wing, adhering to the lower curved surface of the trailing edge of the wing at the flap well, thence inboard to the fuselage and across the rear window. Since the window seal is often not perfectly tight the fuel may then enter the cabin wall.

To preclude the fire hazard of fuel soaked insulation within the cabin wall due to these causes, a drip strip similar to that shown in Figure 1 should be installed on the underside of each wing. This drip strip will prevent fuel from flowing from the wing to the fuselage.
