Airworthiness Directive

Amendment 39-5338; AD **72-06-05** R2

Airworthiness Directives; MARVEL SCHEBLER (Facet Aerospace Products Company): Applies to Models MA-3, MA-3A, MA3-PA, MA-3SPA, MA4-SPA, MA4-5, MA4-5AA, MA-5, MA-5AA, MA-6AA and HA-6 Carburetors

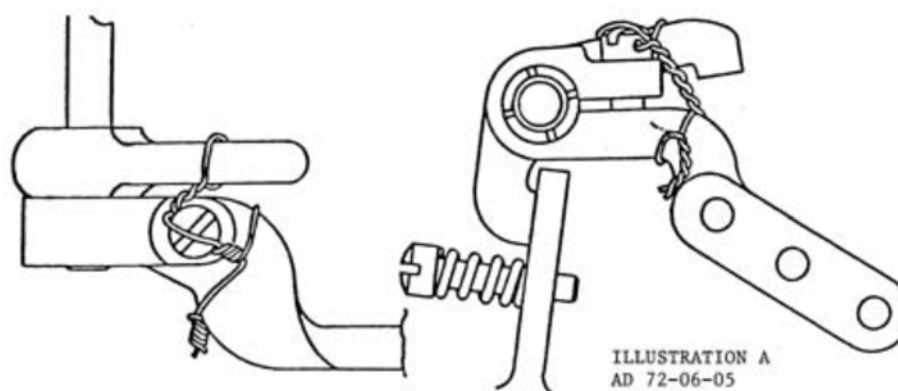
(2) Inspect the throttle arm on Marvel Schebler MA-3, MA-3A, MA-3PA, MA3-SPA, and MA-4SPA carburetors to determine whether it has a spotfaced or milled flat for the head of the clamping screw. Replace any arm having a milled flat with one having a spotfaced flat. If not already installed, install a Marvel Schebler P/N A15-493 clamping screw (No. 10-24 x 5/8 slotted drilled fillister head) in the throttle arm. Torque the clamping screw to 20-28 in.-lb. and inspect the slot in the end of the arm for clearance. If the slot has closed so that no clearance remains, replace the arm and retorque to the above specifications. After the specified torque is established safety wire the throttle arm and clamping screw to the throttle stop as shown in Illustration A.

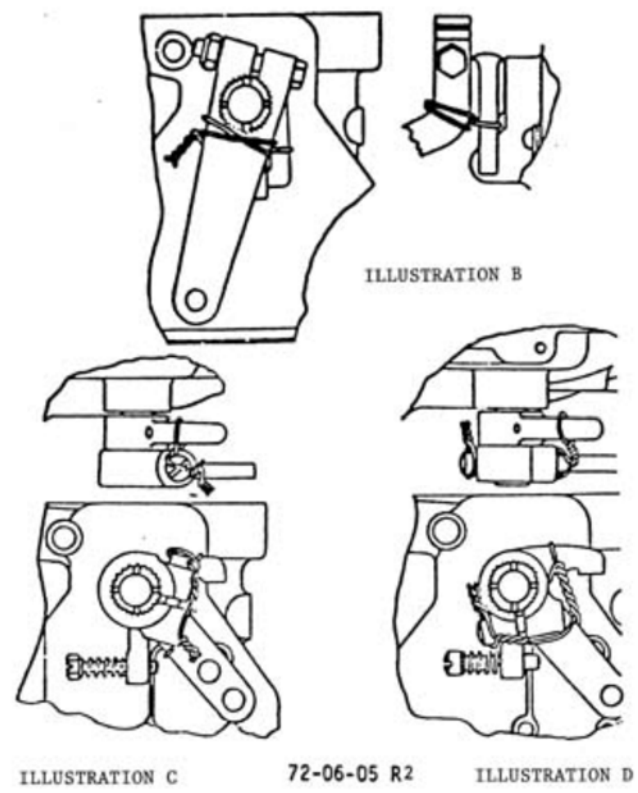
(3) On Marvel Schebler MA-4-5, MA4-5AA, MA-5AA, MA-6AA, and HA-6 series carburetors with throttle arms having a 10-32 bolt and nut clamping the arm on the throttle stop, torque the nut to 35 to 40 in. lbs. and safety wire the throttle arm to the throttle stop as shown in Illustration B. On these series carburetors having a throttle arm threaded for a 10-24 screw, if not already installed, install a Marvel Schebler P/N A15-493 clamping screw (No. 10-24 x 5/8 slotted drilled fillister head) in the throttle arm and torque the screw to 20 to 28 in. lbs. Safety wire the throttle arm to the throttle stop as shown in Illustration C or D.
