OVERHAUL CHANGE NO. 8

CONNECTING ROD MODIFICATION

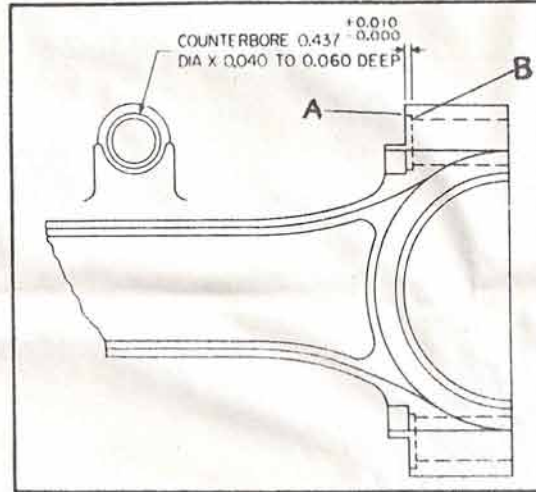
Figure 8-2

a. To provide instructions for modification of connecting rod assembly, part No. 17541, to prevent interference between the edge of the connecting rod bolt hole and the fillet of the connecting rod bolt head resulting in possible failure of the bolt.

b. Counterbore the blade half of the connecting rod at the bolt head end of both bolt holes to a diameter of 0.437 +0.010 inch in accordance with figure 8-2.
-0.000

c. Burr mouth of counterbore (A, Figure 8-2) using hand ball burr. Remove minimum stock.

d. Burr bolt hole edge (B, Figure 8-2) using 60° included hand burr. Remove minimum stock.
