## FRANKLIN SERVICE BULLETIN

NO. 69

DATE: August 17, 1948

**SUBJECT:** CYLINDERS USED ON MODEL 6A4-150-B3 AND B31 ENGINES IN THE EARLY 11,000 SERIAL NUMBER SERIES ON STINSON AND BELLANCA INSTALLATIONS

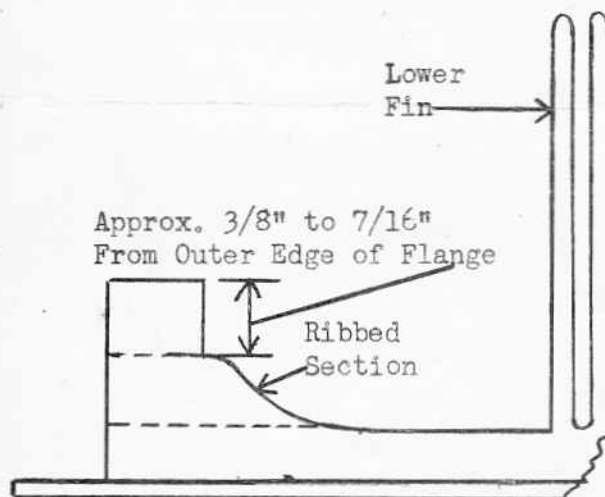
EARLY TYPE

Examination of several cylinders indicates that cracks develop just above the base flange where the cylinder is bolted to the crankcase. Cracks are indicated in the thin wall section and also carry around the top section of the base flange in the pockets where the cylinder hold-down nuts are located.

This condition has been experienced only on the early engines which did not have the ribbed section below the fins extending out close to the outer section of the base flange itself. The ribbed sections are located in the area between the cylinder hold-down stud holes.

Note on early type cylinders the ribbed section stops abruptly at the base flange section facing toward the fins. The base flange section from that point to the outer edge of the flange is flat for a distance of approximately  $3/8$ " to  $7/16$ ", as shown.

Also, at top overhaul and major overhaul, or if for any other reason cylinders are removed, all early type cylinders must be replaced with late type.

It is mandatory that replacement of early type cylinders on engines in aircraft be made and visual inspection should be made for cracks every 25 hours until replacement is made.

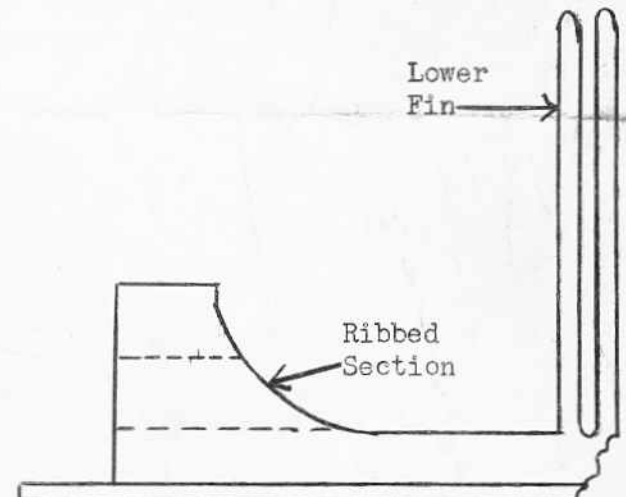
LATE TYPE

Note that on the late type the ribbed section carries out in a gradual radius close to the edge of the flange and the base flange does not have the 3/8" flat section, as mentioned previously.
