SERVICE BULLETIN

AIRCOOLED MOTORS INC.
SYRACUSE 8, NEW YORK

NO. B-98

SUBJECT: CYLINDER ASSEMBLY-INSPECTION OF HOLD-DOWN WASHER SPOT FACE AREA

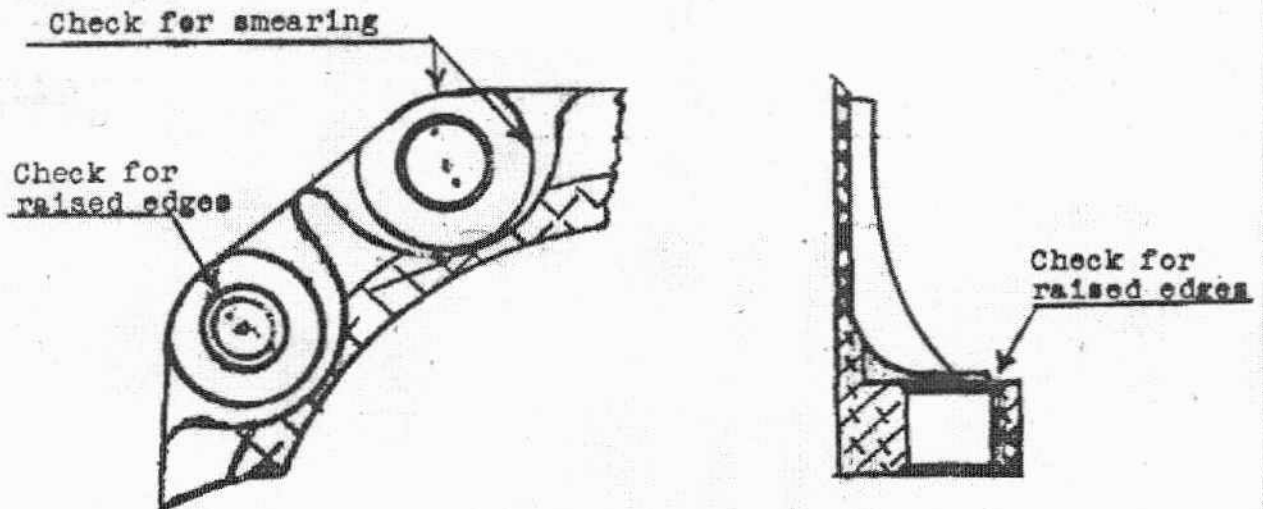
FIGURE I

REASON FOR BULLETIN: To provide instructions for inspection of cylinder hold-down washer spot face area. If this inspection is not completed, cylinder hold-down washers may not seat properly thus causing stresses on the cylinder flange and possible cylinder failure.

DETAILED INSTRUCTIONS: Inspect all cylinder mounting flanges at the spot faced area for raised edges at the stud holes and smearing at the spot face outside diameter. (See Figure I).

If raised edges are observed around the stud hole, lightly scrap away all raised material with a hand scraper, until the area is flush with the spot faced section.

If smearing is noted at the spot face outside diameter, carefully scrap away the excess with a hand scraper until a cylinder hold-down washer seats perfectly on the spot face.

Care must be used to prevent damage to the spot face fillets if scraping is required.
