SERVICE NEWS

AIRCOOLED MOTORS INC.
SYRACUSE 8, NEW YORK

NO. 19

SUBJECT: MODIFICATION OF FRANKLIN MODEL 6A4-150-B3 ENGINES TO PROVIDE FOR USE OF AN OIL CONTROL PROPELLER

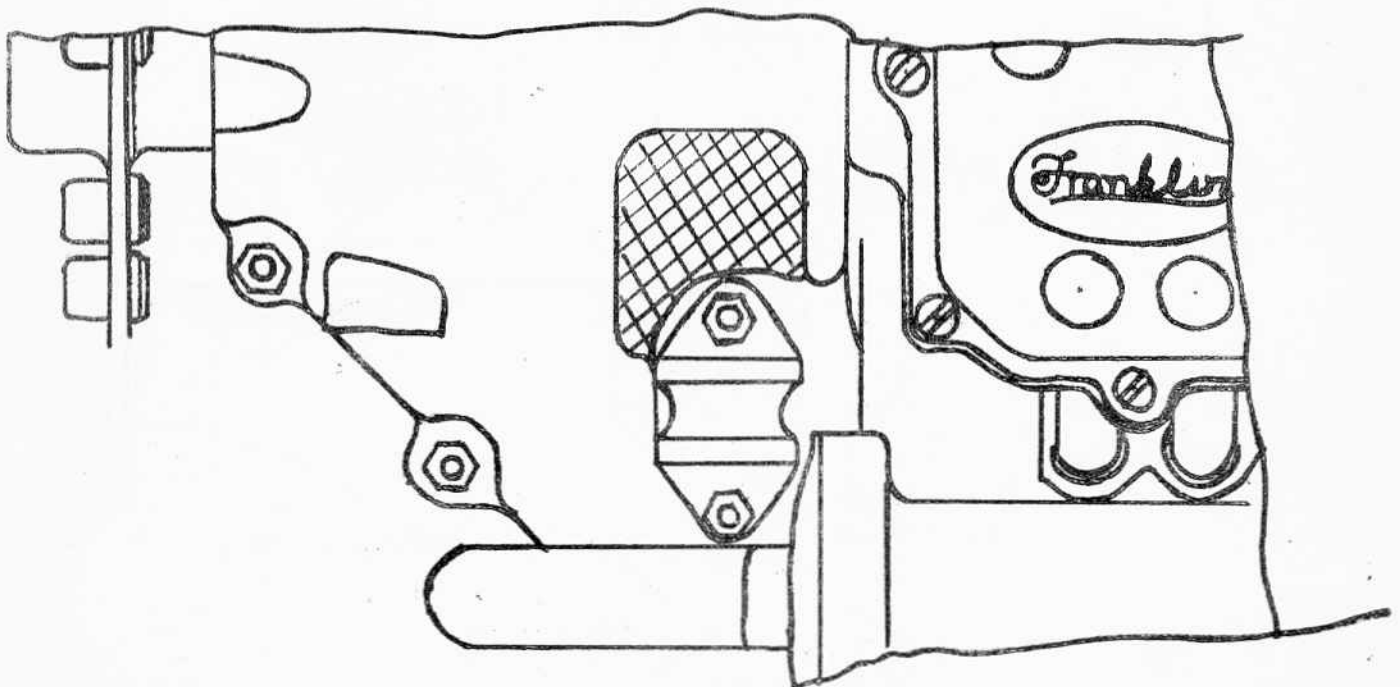
FIGURE ONE

Figure One shows the nose end of the left half of the crankcase. If the crankcase has a flat machined surface (shaded area of Figure One) above the engine mount bracket pad, the crankcase can be modified. If there is no machined surface above the mount bracket pad, the modification cannot be completed.

The crankshaft must be reworked by drilling an oil passage to transfer oil from No. 4 main journal to the flange end of the crankshaft. The flange end of the crankshaft must be ground to provide for installation of a plug.

Three passages must be drilled in the crankcase to direct oil to the governor control. Drilling and tapping must be provided for mounting the governor.

Upon completion of the modification, propeller end crankshaft bushings, part numbers 17665 and 17666, or comparable undersize bushings, must be installed at time of assembly.
