SERVICE BULLETIN

TITLE Wheel Pants Reinforcement

BULLETIN NO. 235

MODELS AFFECTED: 108 (Voyager 150) Serial 108-1
through 108-234

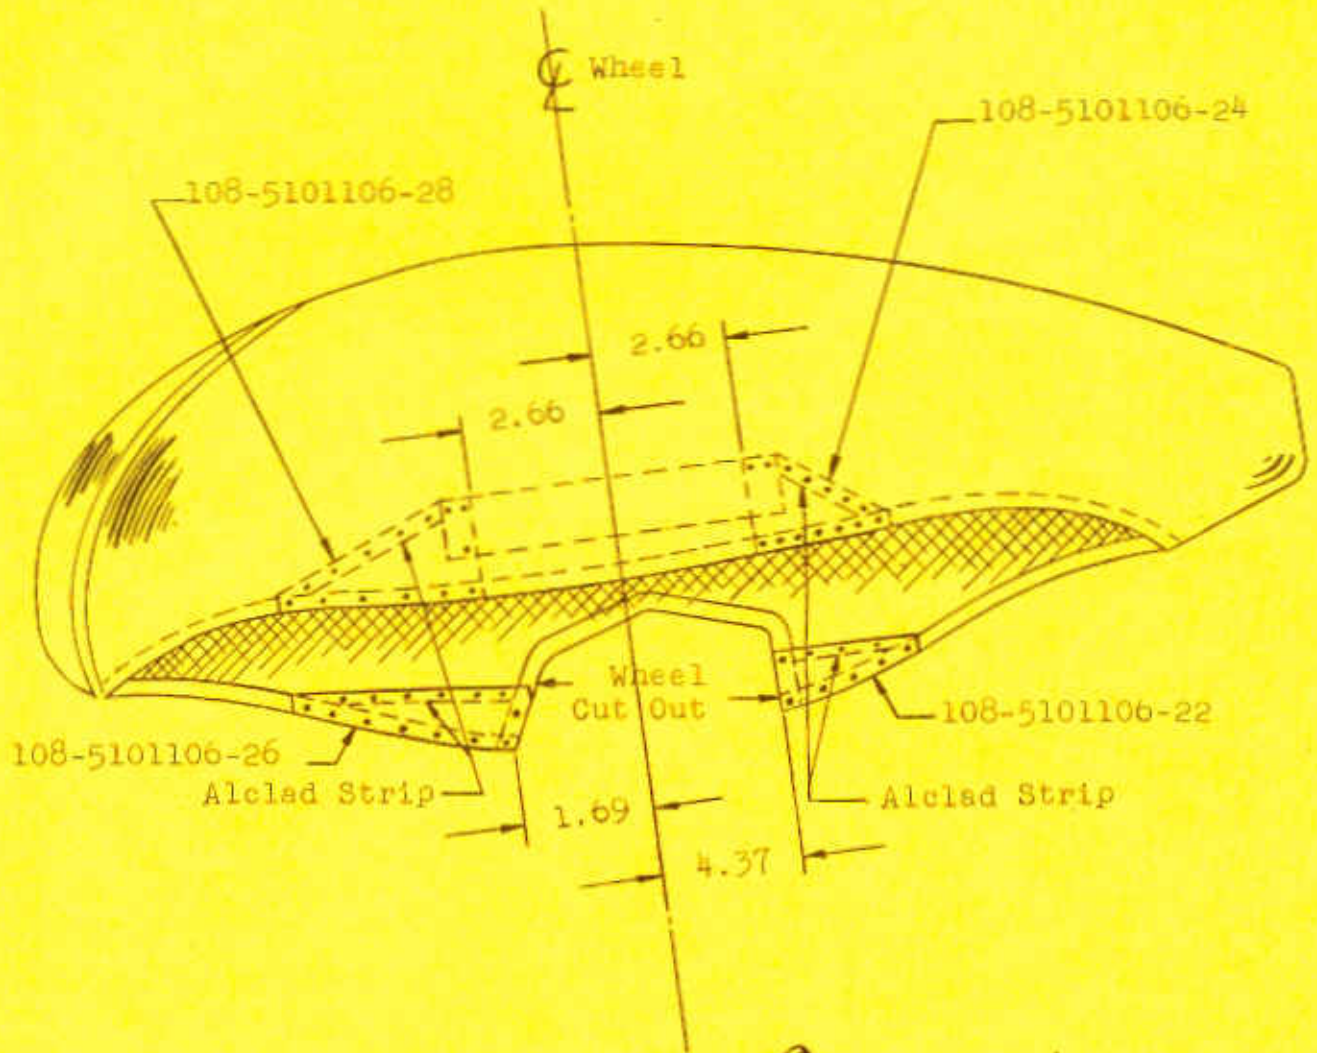
Experience in the field with the Voyager 150 indicates a definite need for reinforcing the structure of the wheel pants. Correction work on the above models should be performed as indicated in the following instructions. This change will be incorporated in airplanes bearing serial 108-235 and up.

Install plates on inside of pants as shown in sketches on page 2 of this bulletin. Cut proper lengths of the 1/2" alclad strip for filler under edge of plate so rivets will not buckle skin. Use #40 (.098) drill for rivet holes. Where factory installed rivets interfere with reinforcing plate, drill out rivet and use hole for attaching plate with new rivet.

Trim and file reinforcements on bottom outside and around cutout on inside of pant.

When installing wheel pant use #8 machine screws and elastic stop nuts provided, in place of the sheet metal screws and tinnerman nuts originally used.
