SERVICE BULLETIN

STINSON DIVISION

TITLE Chafed Lift Struts

BULLETIN NO. 241

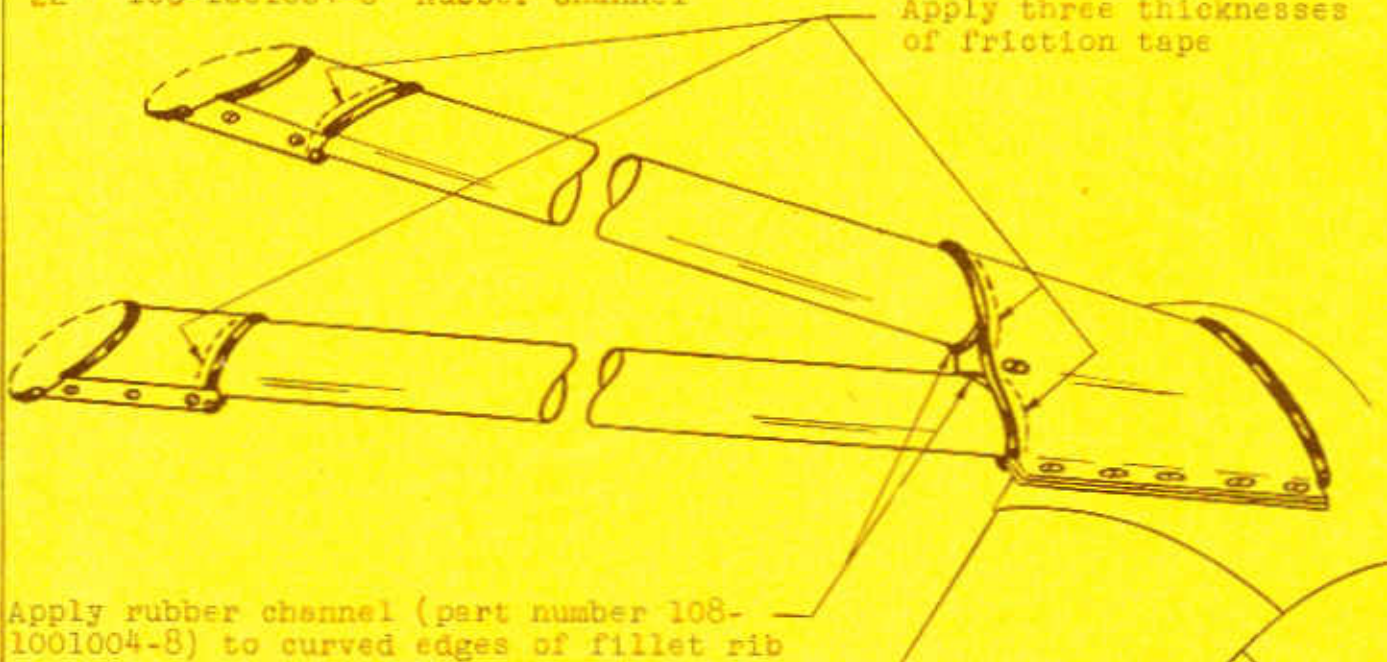
It has come to our attention that the upper and lower lift strut boots, in a few instances, have chafed the lift struts, therefore, the following inspection and precautionary action is recommended.

Remove the lift strut boots and examine the struts for scratches caused by chafing action of the boots. If scratches deeper than .015" on the rear strut and .020" on the front strut are evident, the struts should be replaced. Scratches of lesser depth are not considered serious and it will only be necessary that they be burnished to remove their sharp edges.

Before the lift strut boots are reinstalled, wrap the struts with three thicknesses of friction tape in the region under the edge of the boots. Cement rubber channel (part number 108-1001004-8) on the fillet rib which fits between the lower ends of the struts. The rubber channel may be secured without charge from the Service Department.

Apply three thicknesses of friction tape

Apply rubber channel (part number 108-1001004-8) to curved edges of fillet rib
