# SERVICE BULLETIN

TITLE Wing Drag Wires - Periodic Inspection

BULLETIN NO. 243

MODELS AFFECTED: 108 (Voyager 150) 108-1 through  
108-969, 108-971 through 108-975

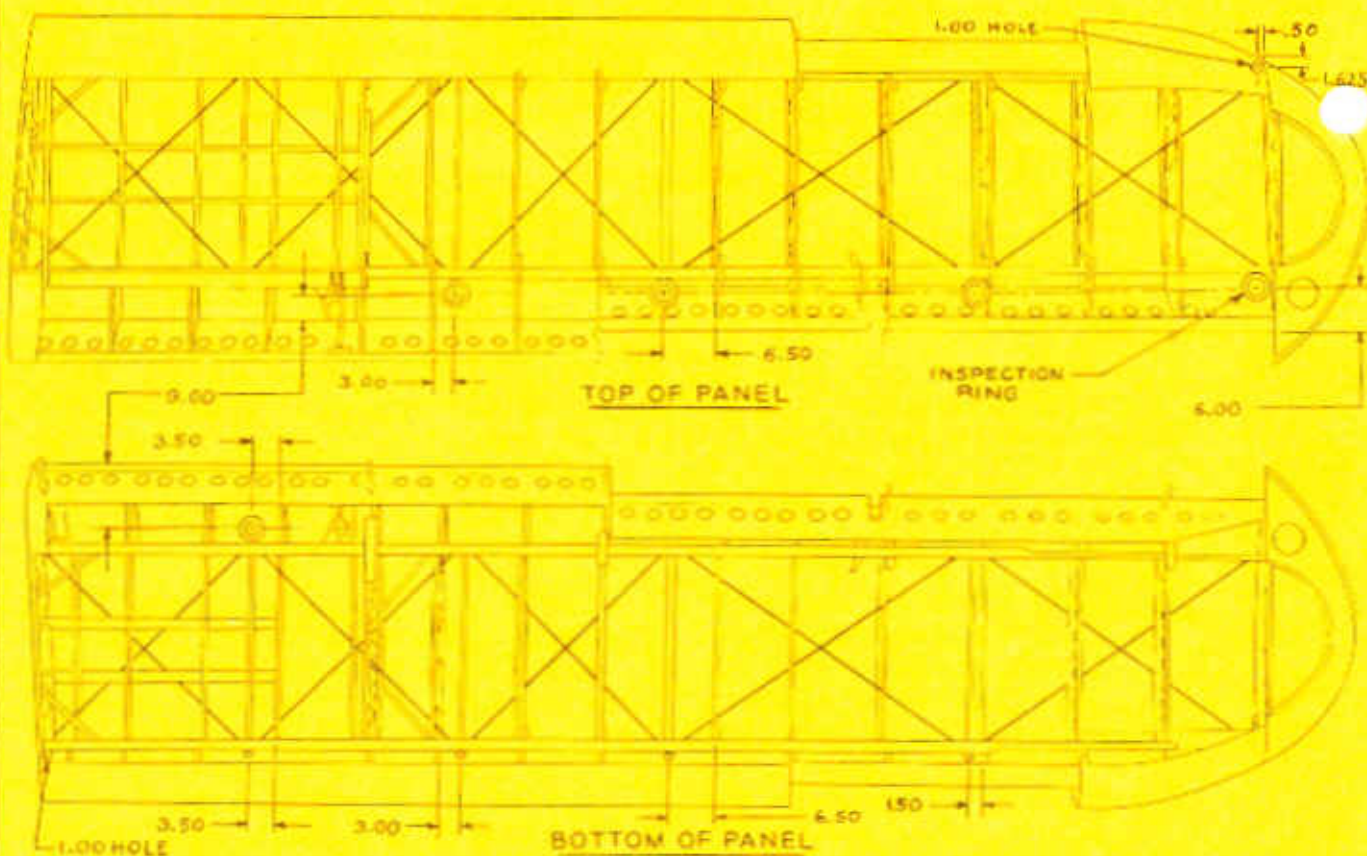
On Stinson Voyager 150 airplanes in the above category it will be necessary to check the drag wires for tautness at each 100 hour inspection. Any wires found loose must be tightened and the threads staked against the outer face of the nuts. The most vulnerable spot for a loose drag wire condition will be between the lift strut and the wing tip. It is, therefore, recommended that this inspection be started from the wing tip inboard. The following procedure is recommended for inspection and correction of drag wire tension:

2. If, after inspection, it is found that a loose drag wire condition exists, establish location points for access holes in the wing cover to permit tightening.

1. Remove inspection covers on the bottom surface of the wing panels between the spars. Cut out centers of inspection rings where necessary to reach all drag wires. Inspect each drag wire for tension.

3. After determining proposed location of access holes (next to, but not over, the spar and rib members) reinforcement rings #37 should be doped to the fabric cover. Allow fifteen minutes for dope to dry before cutting center from ring.

4. The small-1"-holes in the wing leading edge do not require reinforcement rings. These holes should not exceed 1" in diameter. The small hole at the wing tip, of necessity, will extend through the metal leading edge skin as well as the fabric. A key hole saw or small tin snips are recommended for this operation.

5. Hold forward nut on wire with a wrench through small hole in wing leading edge. Tighten aft nut on wire through large inspection hole in wing trailing edge. To avoid possible misalignment of aileron or flap hinges, do not tighten nut excessively.

6. Stake the threads at each nut using a small chisel or center punch. Stake should be about .05 inches deep and as close to nut as possible.
7. Cover inspection holes with #52 covers. Small 1" holes

should be covered with a fabric patch at least 5" square. Apply three coats of clear dope to patch followed by pigmented dope to match wing panel.
