SERVICE BULLETIN

TITLE: Protection of Wiring Harness

BULLETIN NO. 248-A

MODELS AFFECTED: 108-1 through 108-2394

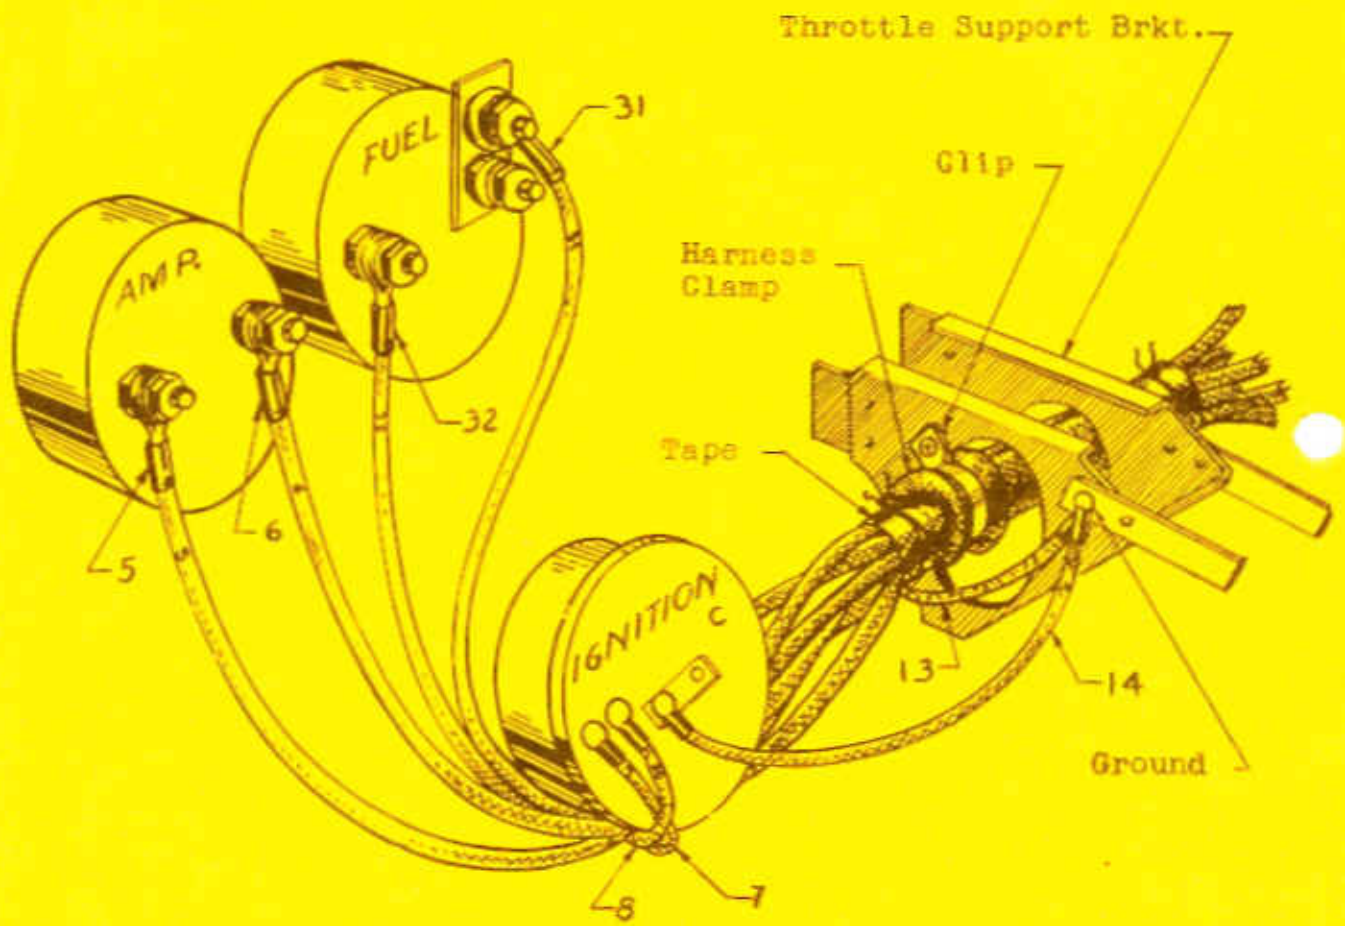
Figure 1

As a precautionary measure we recommend that airplanes within the above serial numbers be examined for possible chafing of the wiring harness at the throttle bracket behind the instrument panel. Should such a condition exist, the following corrective procedure is suggested:

Pull wires to left of panel and wrap into a bundle, using coreprene tape where the wires pass the throttle bracket. Taped area should be about ten inches long. Tie each end of the wrapped area with lacing cord to prevent any possibility of unwinding after performing this correction work.

Thread the wrapped wires underneath the carburetor heat control and through the lightening hole in the throttle support bracket. Install clip and harness clamp as shown in the illustration on the reverse side of this page. Secure the wrapped wires in the harness clamp.
