SERVICE BULLETIN

STINSON DIVISION
CONSOLIDATED VULTEE AIRCRAFT CORPORATION
WAYNE, MICHIGAN

TITLE: Replacement of "Click" Washer in Fuel Valve

BULLETIN NO. 250

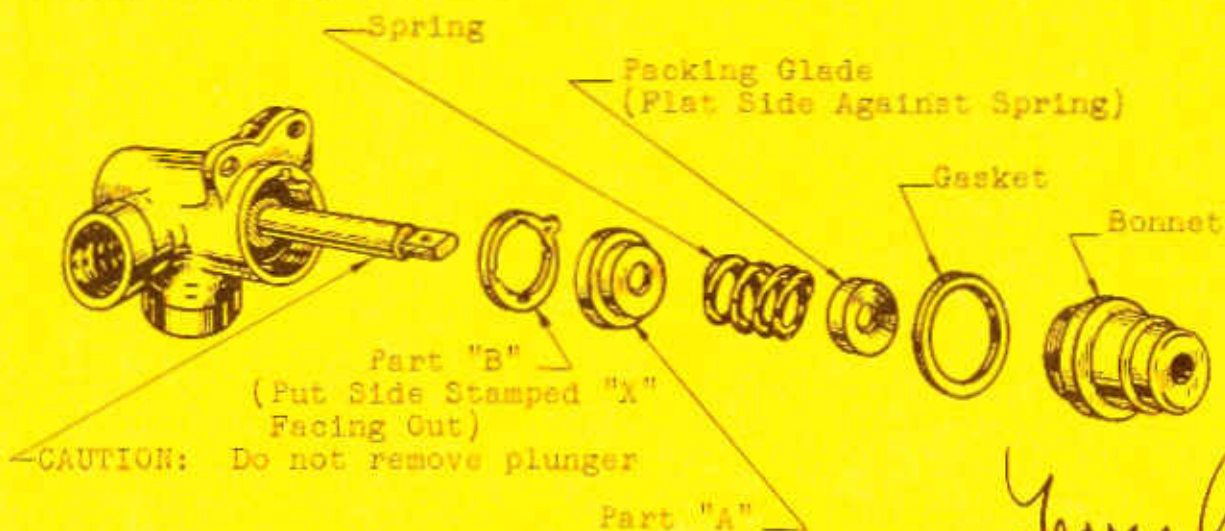
In order to restore the position locating feature in the fuel tank selector valve and assure positive operation of the valve at all times, it is recommended that the subject replacement be made in all 165 horsepower Voyager and Flying Station Wagon airplanes within the serial numbers noted above.

Necessary parts, marked "A" and "B" on Figure 1, are being forwarded under separate cover without charge.

Drain the fuel from both tanks and drain the fuel lines at the strainer on the firewall. Disconnect control shaft from fuel valve. Remove bonnet from valve and disassemble valve to the extent shown in Figure 1. Parts "A" and "B" are to be replaced with the new parts furnished. Reassemble valve and attach control shaft. When reinstalling part "B" position the tab in the groove off-set to the right. The side of the washer marked "X" should face out of the valve. **IT IS IMPORTANT THAT THE TAB BE INSTALLED IN THE GROOVE OFF-SET TO THE RIGHT OTHERWISE THE VALVE POSITION INDICATOR WILL NOT INDICATE CORRECTLY.**
