SERVICE BULLETIN

STINSON DIVISION
CONSOLIDATED VULTEE AIRCRAFT CORPORATION
WAYNE, MICHIGAN

TITLE: Fuel Gauge Modification BULLETIN NO. 251
MODELS AFFECTED: 108 (Voyager and Flying Station Wagon) Serial Numbers 108-1 through 108-41, 108-43, 108-287 through 108-2849 PAGE 1 OF 2
DATE: June 27, 1947

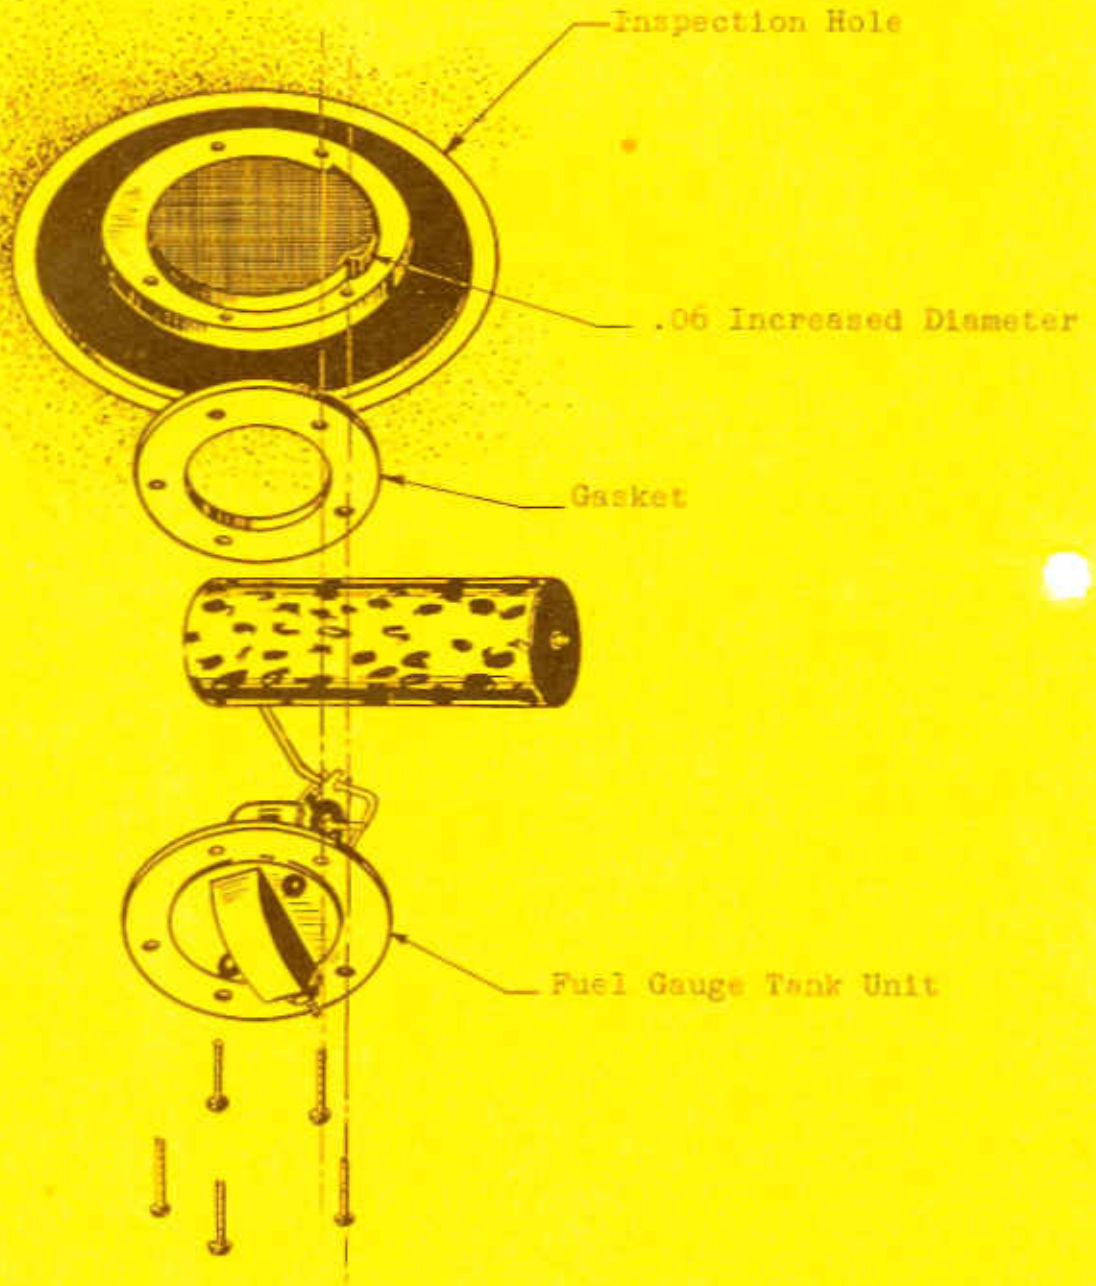
We have found in some airplanes a definite indication of interference between the gas gauge tank unit float arm and the cast aluminum adapter in which the gas gauge tank unit is mounted. This interference prevents the fuel gauge from properly registering the quantity of fuel in the tank. To remedy this condition the following modification is recommended:

Increase the inside diameter of the cast aluminum adapter in the tank by filing .06 inches from the inside of the ring in the region of the float arm (See Illustration on Page 2). The area to be filed will be self-evident upon inspection inasmuch as the tank unit will only fit the adapter in one way.

IMPORTANT: File cast aluminum adapter using downward stroke only. Do not allow file to contact adapter on upward stroke.
