# SERVICE BULLETIN

TITLE: Tail Wheel Installation

BULLETIN NO. 252

MODELS AFFECTED: 108 (Voyager and Flying Station  
Wagon)

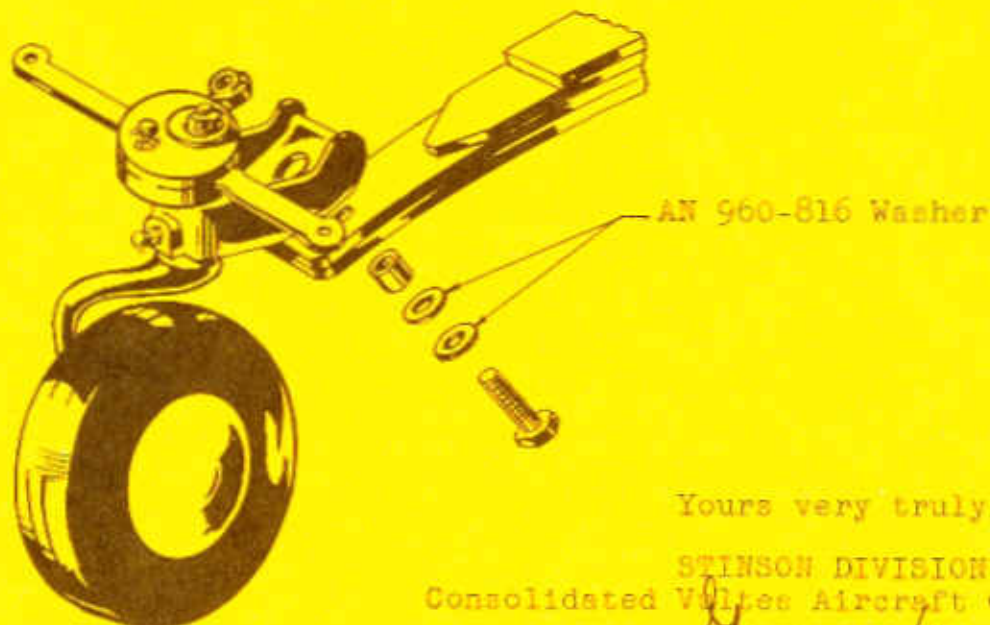
We recently received several reports on the subject of malfunctioning steerable tail wheels. A complete investigation of this subject indicated that the tail wheel steering arms were of proper specifications and that the difficulty, where encountered, was caused by the tail wheel arm striking the end of the tail wheel installation bolt. When the tail wheel steering arm swings forward it strikes the end of the bolt and jams the tail wheel mechanism before it reaches the release point.

If any Voyagers in your territory are reported to be experiencing this type of difficulty, we recommend that the tail wheel assembly bolt be removed and two washers installed under the head of the bolt as indicated in the sketch below.
