SERVICE BULLETIN

TITLE: Inspection of Stabilizer Leading Edge
Attachment

BULLETIN NO. 254

MODELS AFFECTED: 108 (Voyager and Flying Station
Wagon). Serial 108-1 through 108-
3500, Inclusive

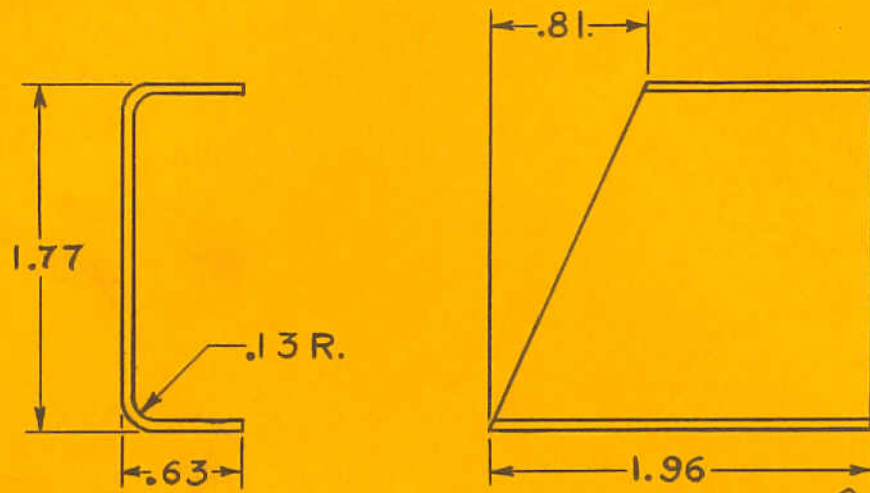
To determine whether or not fatigue cracks have developed in the fitting that attaches the horizontal stabilizer to the fin, it is recommended that all airplanes in the above category be inspected at this point. It is further recommended that this inspection be made after each 100 hours of operation.

If fatigue cracks have developed, the following corrective action should be performed:

1. Remove the horizontal stabilizer forward attaching bolts and drop the leading edge to insure accessibility.
2. Drill a 1/16" stop-hole at each end of the crack to prevent spreading.
3. Fabricate and attach reinforcing channel to the stabilizer fitting as shown in the following sketch.

1 Piece 24ST Aluminum Sheet - .040 - 2" x 3"
7 - AN442-AD5 Rivets

Locate two rivets
through web to clear
crack
