SERVICE BULLETIN

STINSON DIVISION
CONSOLIDATED VULTURE AIRCRAFT CORPORATION
WAYNE, MICHIGAN

TITLE: Elevator Trim Tab Control Horn

BULLETIN NO. 257

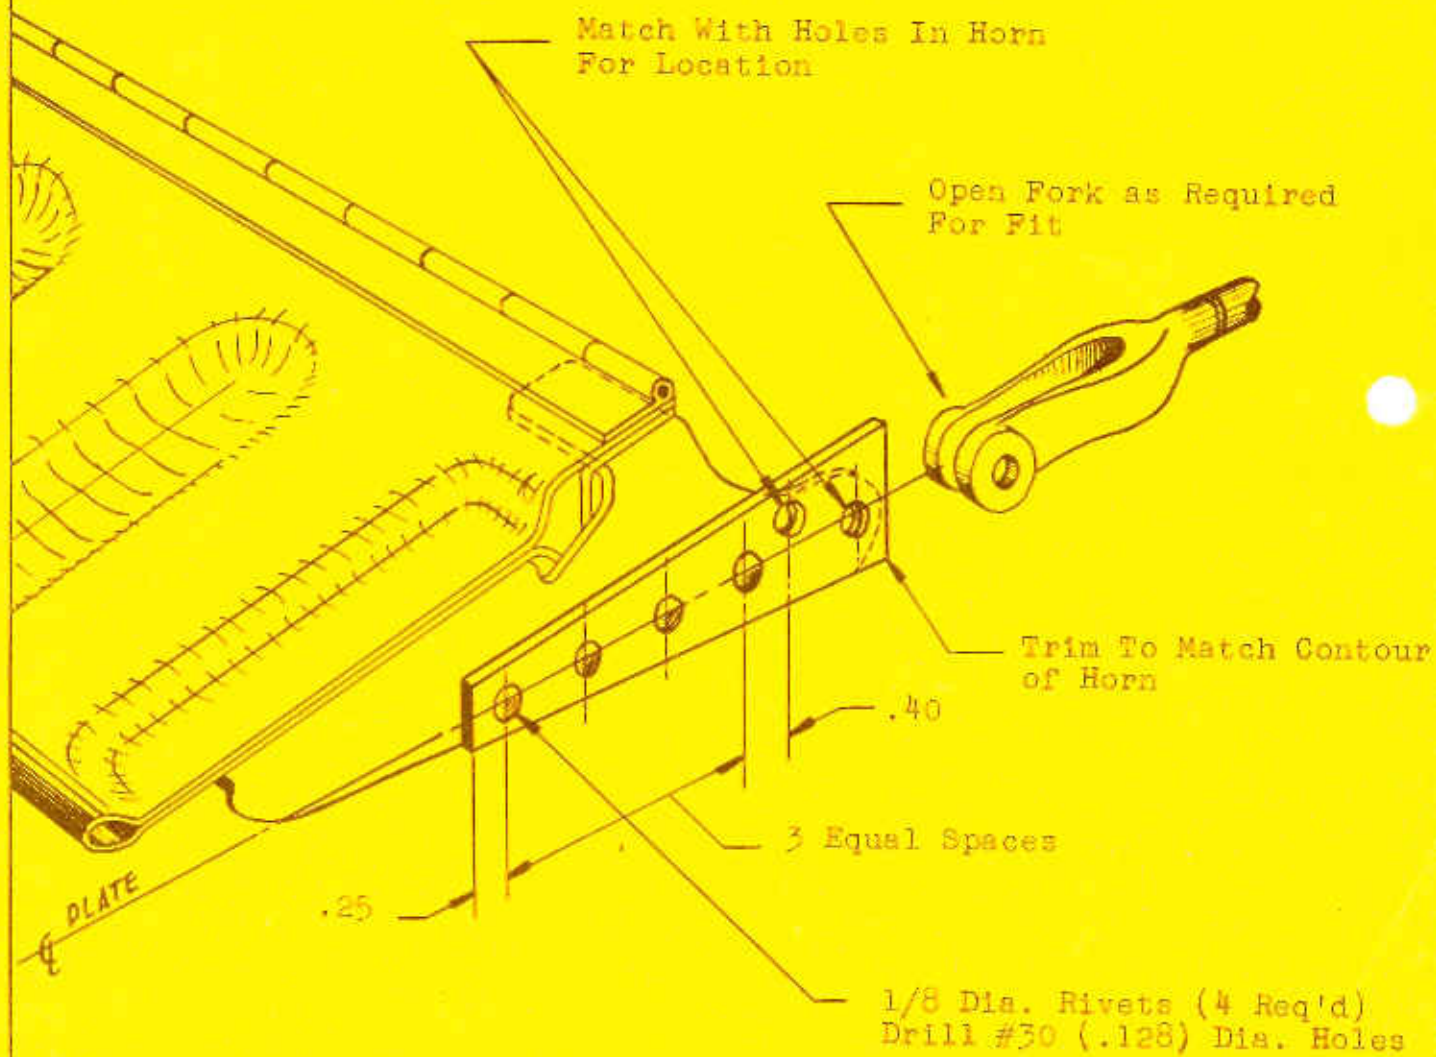
It has been found that in some cases the hole in the elevator tab control horn has elongated. Effective on airplane serial number 108-4760 the gauge of the horn has been increased to eliminate this possibility.

2. Disconnect elevator trim tab flexible shaft fork.
3. Bolt reinforcing plate (Part Number 108-2201013-6) to elevator trim tab control horn and drill rivet holes in accordance with sketch.

4. Trim forward edge of reinforcing plate to match the contour of the elevator trim tab control horn.
5. After riveting the reinforcing plate to the horn it may be necessary to open the fork to permit its attachment. See sketch.

6. Use the upper aft hole for attachment of the control horn for the model 108-3 only. On all other models use the outermost hole.
