# SERVICE BULLETIN

TITLE Repair or reinforcement of Rudder Skins  
at Tab Hinge

BULLETIN NO. 258

MODELS AFFECTED: 108-3 -Serial Numbers 108-3502  
thru 108-4930.

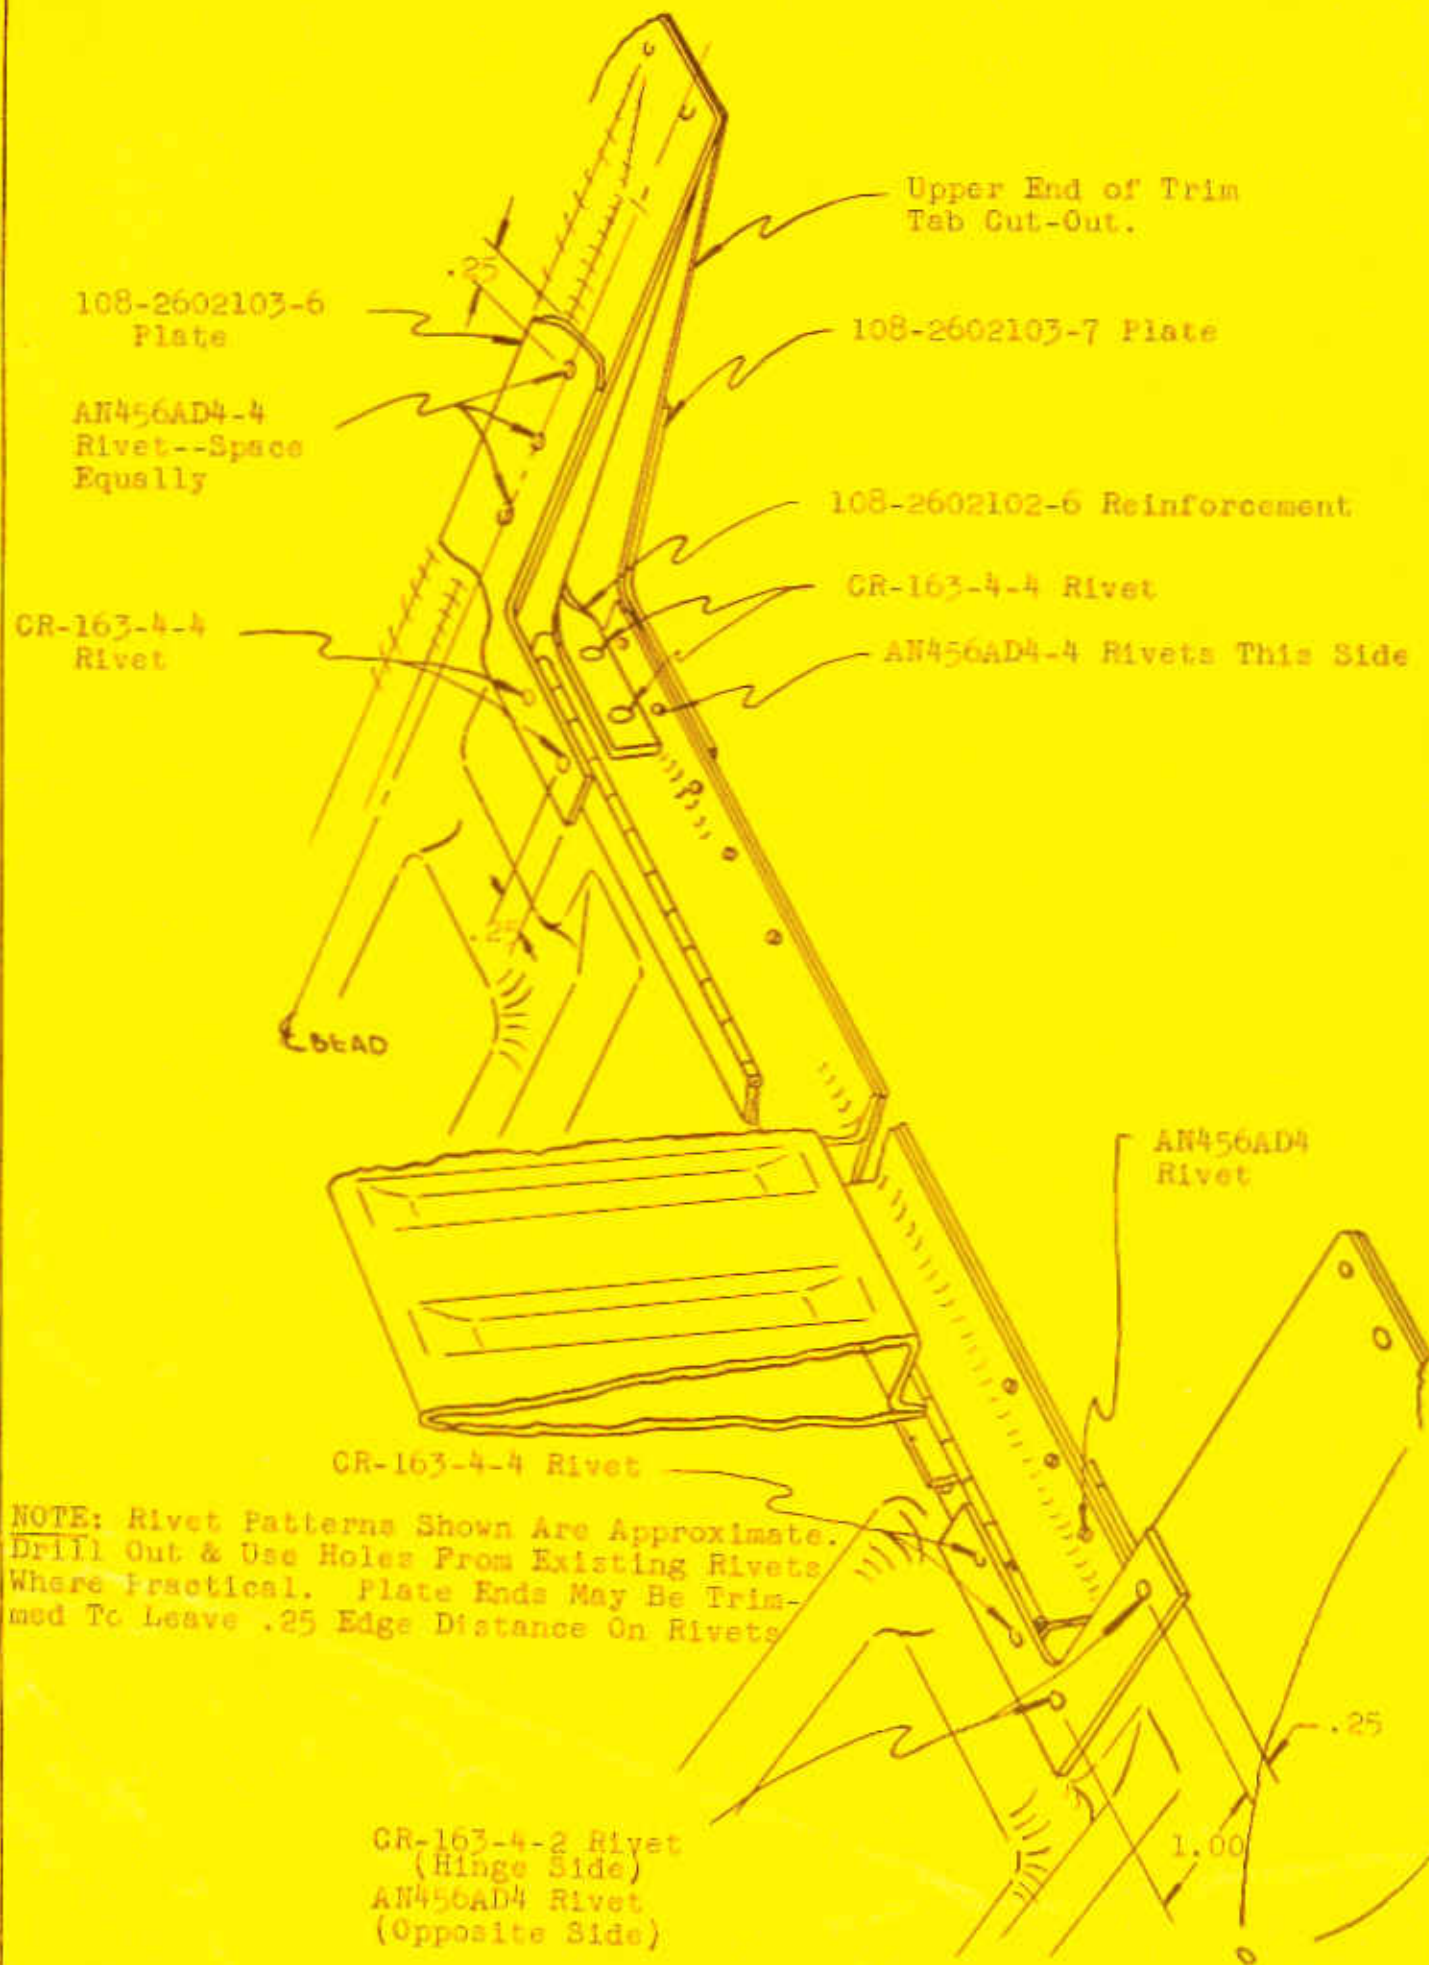
A. Inspect rudder skins at points immediately adjacent to the upper and lower ends of the rudder tab hinge for cracks. If cracks are not present, we recommend the installation of reinforcement, part number 108-2602102-6, to preclude the possibility of cracking. This reinforcement is installed at the factory on airplanes bearing serial number 108-4931 and up. Installation instructions follow:

B. Where cracked rudder skins are found adjacent to the top of the rudder tab hinge, the following repairs should be made.

C. Where cracked rudder skins are found adjacent to the lower end of the tsb hinge, the following repairs should be made.

1. Detach rudder tab flexible shaft at tab end.
2. Position reinforcement, part number 108-2602102-6, as shown on drawing on page 3.
3. Attach reinforcement to rudder with two (2) Cherry Rivets CR-163-4-4 through rudder false spar and one (1) Brazier Head Rivet AN456AD4-4 through rudder skins at center of bead. Drill .128 diameter holes for rivets.

1. Detach rudder tab flexible shaft at tab end.
2. Install reinforcement, part number 108-2602102-6, as outlined in paragraph A above, EXCEPT DO NOT INSTALL AN456AD4-4 rivet through rudder skins.

3. Drill #40 (.098 dia.) stop hole at end of cracks in rudder skins.
4. If the rudder skin is cracked on the tab hinge side, drill out the top two rivets which attach the tab hinge to the rudder. If the skin is cracked on the side opposite the tab hinge, drill out the two top rivets on that side. Naturally, if the skins are cracked on both sides, all four rivets must be removed.

5. Install reinforcement plate, part number 108-2602103-6, over crack on tab hinge side and plate, 108-2602103-7, over crack on opposite side.
6. Drill .128 diameter holes through plate (or plates) to pick up holes from drilled out rivets. Drill .128 hole through plate (or plates) at center of skin bead. Drill additional hole through plate (or plates) so as to have three holes equally spaced on the centerline of the skin bead.

7. Attach plate (or plates) with three Brazier Head rivets AN456AD4-4 through skin beads. Use two (2) Cherry rivets CR-163-4-4 to attach plate to hinge side of rudder and two (2) Brazier Head rivets AN456AD4-3 on opposite side.

1. Drill a #40 (.098 dis.) stop hole at the end of the crack.
2. If the rudder skin is cracked on the tab hinge side, drill out the two bottom rivets which attach the tab hinge to the rudder. If the skin is cracked on the side opposite the tsb hinge, drill out the two bottom rivets on that side. Naturally, if the skins are cracked on both sides, all four rivets must be removed.

3. On most 108-3 models another rivet was installed directly below the rivets mentioned above. If this rivet is present, it must also be drilled out.
4. Position reinforcement plate, part number 108-2602103-10, and drill .128 diameter holes through plate to pick up holes from drilled out rivets. If the rivet mentioned under item 3 was not present it will be necessary to drill another .128 hole - see drawing. Drill a fourth .128 hole as shown on drawing.

5. Attach plate on hinge side with two Cherry Rivets CR-163-4-4 through plate and hinge. Use Brazier Head rivets AN456AD4-3 in all other holes and for attaching reinforcement plate on side opposite tab hinge.
