SERVICE BULLETIN

STINSON DIVISION
CONSOLIDATED VULTEE AIRCRAFT CORPORATION
WAYNE, MICHIGAN

TITLE: Relocation of Battery Vent Tube

BULLETIN NO. 259

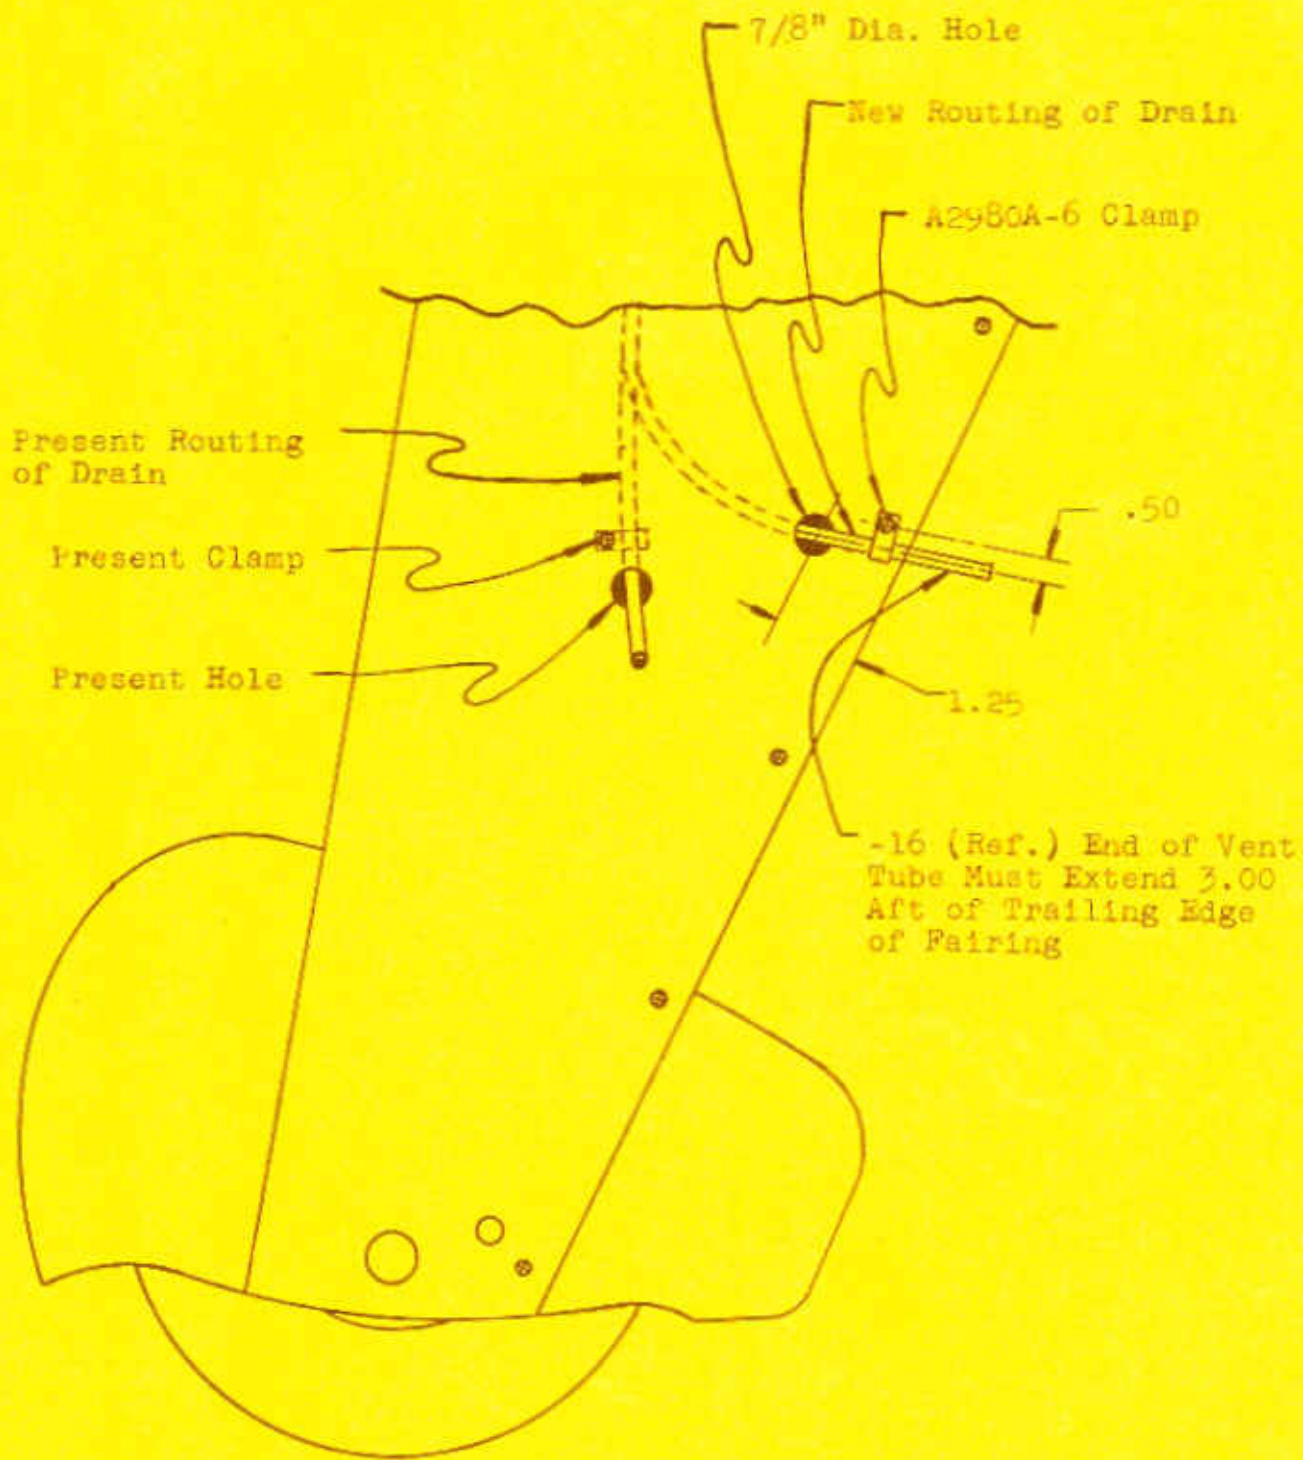
The present location of the battery vent tube, under certain operating conditions, will cause the acid vapors to attack the paint on the landing gear fairing. Tests conducted at the factory prove that relocating this tube will entirely prevent this possibility. The following modification is suggested.

Cut a $7/8$ " diameter hole in the under side of the right landing gear beam fairing at a point near the trailing edge. See sketch. Disassemble trailing edge of the fairing so as to make the vent tube accessible. Reposition tube through the new hole and secure the end of the tube by installing an A2980A-6 clamp. Use a screw which is already installed on the trailing edge of the fairing. Do not remove present hose clamp. The end of the vent tube must extend 3" aft of the fairing trailing edge.

Note: It is not necessary to remove the fairing to perform this work.
