# SERVICE BULLETIN

Stinson Service Bulletin #266  
(Formerly Piper Service Bulletin No. 114)

Subject: Stinson Rudder Cables Model 108; 108-1; 108-2; and 108-3

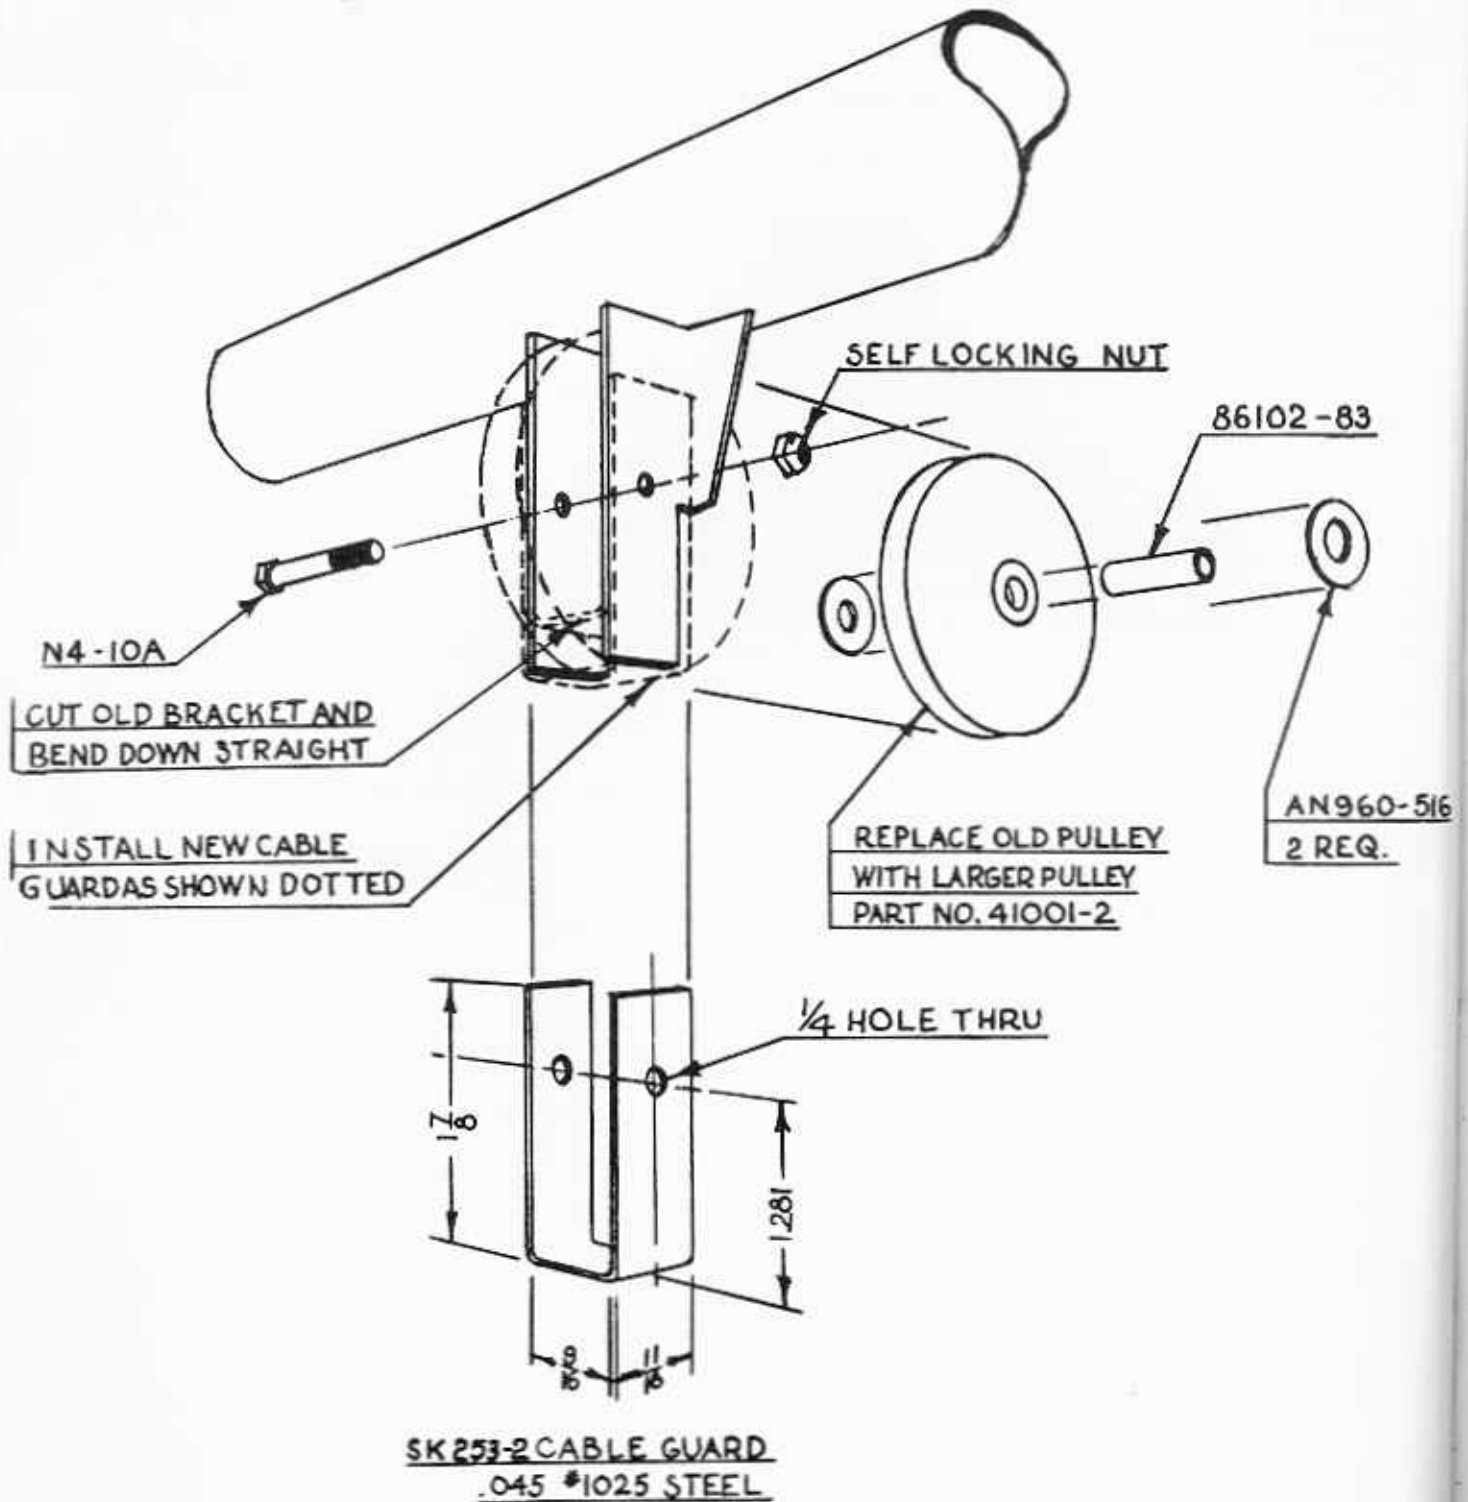
PULLEY BRACKET MODIFICATION  
STINSON 108

We have received several reports from the field that the core strands of the rudder cables were found to be broken at a point where the cable passes over the AN210-3A pulley at fuselage station 18.75, (immediately under rudder pedals.)

The cable strand breakage was caused by too great a degree of bend around the pulley. It is recommended that the pulley modification, as indicated on the accompanying sketch, be accomplished on all subject aircraft. The listed instructions should be followed in performing the modifications:

1. Remove the forward belly access door.
2. Remove the right and left hand landing gear fairing.
3. Peel back the forward edge of the landing gear dust cover strips, which are doped to the metal fuselage cowl, far enough to uncover the pulleys on both sides of the airplane.
4. Remove the AN210-3A Pulley.
5. Cut the pulley brackets, as indicated on sketch.
6. Install two Part Number 41001-2 pulleys and two Part Number SK253-2 Cable Guards.
7. If rudder cables show signs of breakage, they must be replaced.
8. Redope the landing gear dust cover strips to the fuselage cowl.
9. Replace the right and left landing gear fairings.
10. Replace the forward belly access door.
