Piper
Service Bulletin No. 115

Stinson 108
Service Bulletin #267

Subject: Fuel Seepage Into Cabin

To: All Owners of Piper Stinson Model 108, 108-1, 108-2 and
108-3 Airplanes

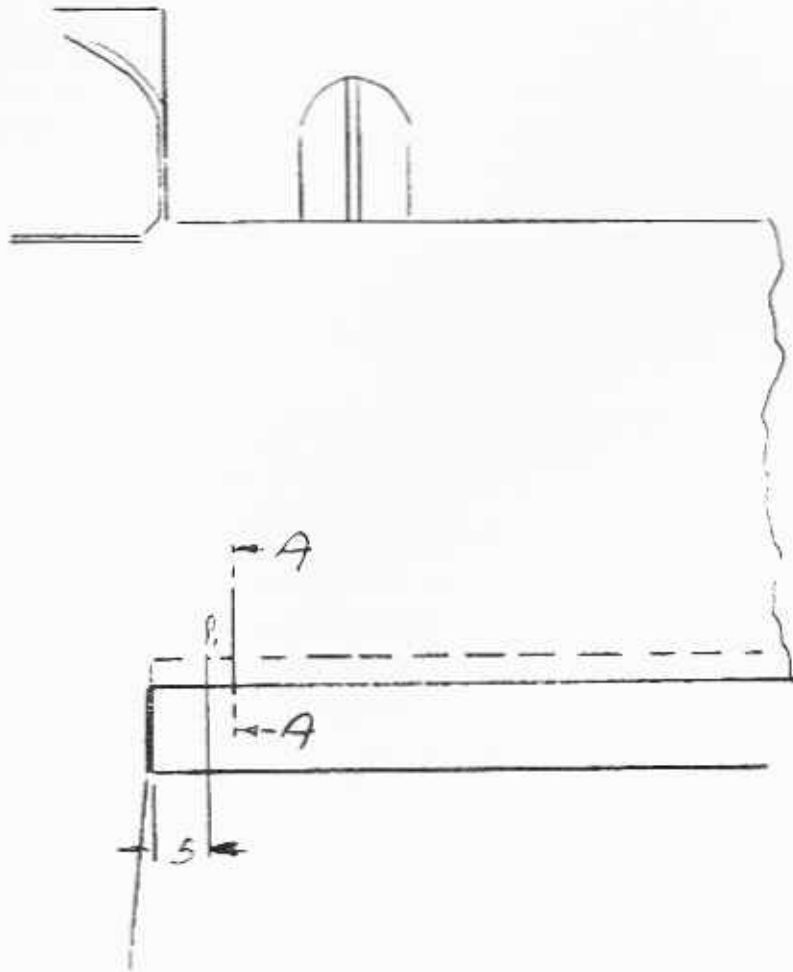
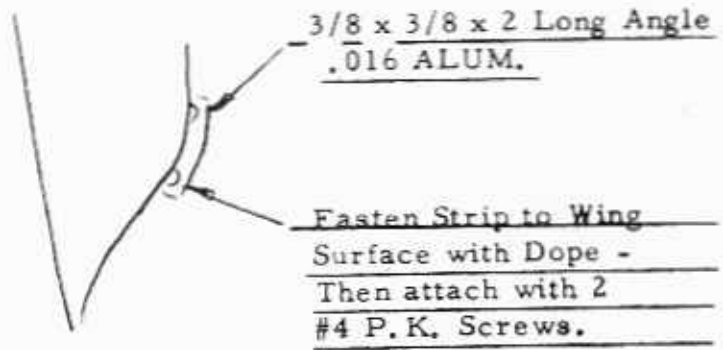
Service Bulletin #115

It has been noted that fuel overflow from the wing tanks tends to run towards the fuselage, creating the possibility of fuel seepage into the cabin.

Fuel overflow runs to the under surface of the wing, adhering to the lower radius of the trailing edge of the wing ribs over the flap span. Due to wing dihedral, the fuel then runs to the fuselage and down across the window.

It is recommended that a drip strip similar to that shown in the sketch on opposite side, be applied to the under surface of the wing.

Any suitable strip may be applied in the location shown that will break adhesion of the fuel to the wing panel.
