SERVICE BULLETIN

TITLE Elevators - Neutral Position

BULLETIN NO. 239

MODELS AFFECTED: 108 (Voyager 150)
108-1 through 108-495, 108-496
and up

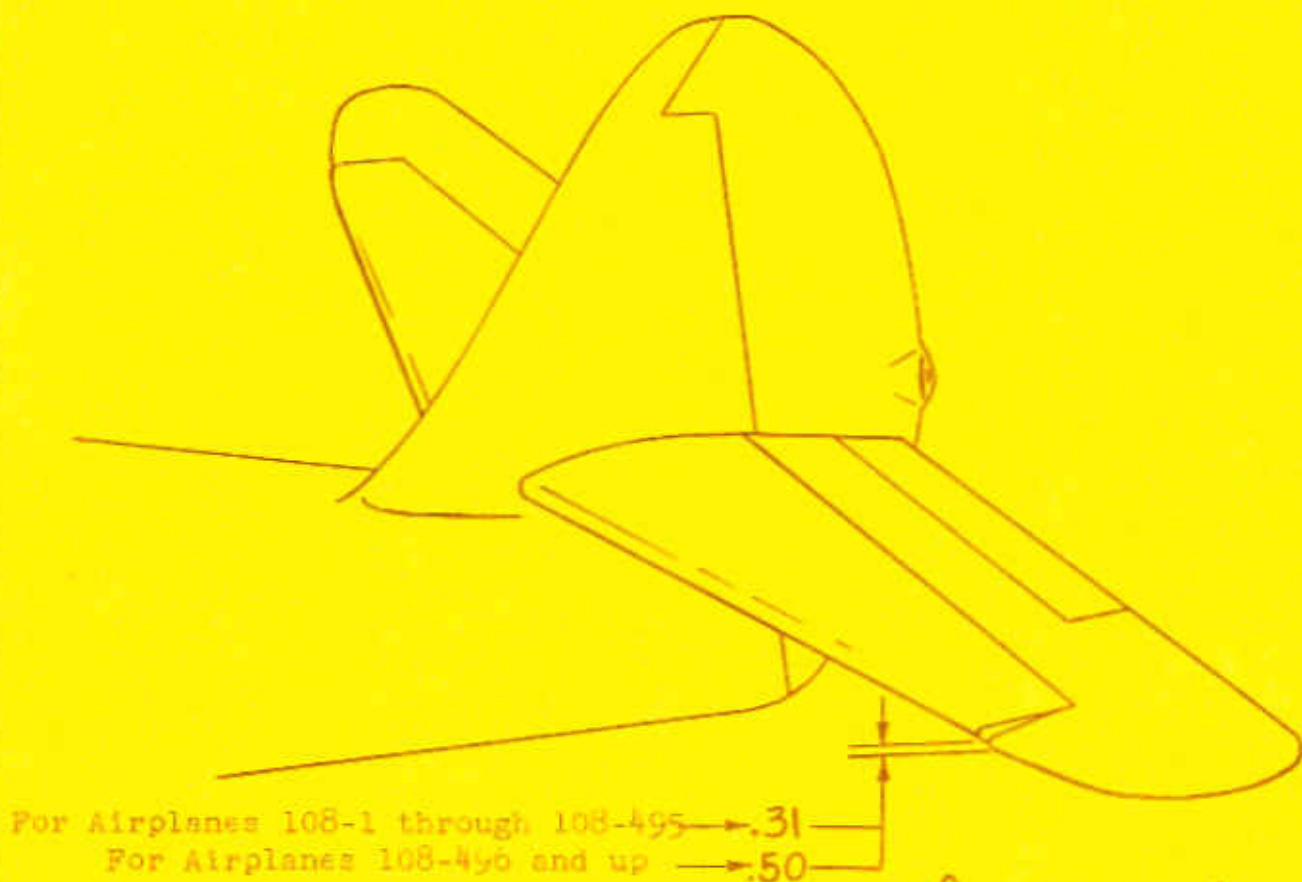
The elevator is in neutral position when the elevator trailing edge is in line with the contour of the horizontal stabilizer. On airplanes 108-1 through 108-495 the elevator is in neutral position when the leading edge at the balance overhang will be $5/16$ " below the leading edge of the horizontal stabilizer. On airplanes 108-496 and up this dimension should be $1/2$ ". Both correct dimensions are indicated in the sketch below.

For Airplanes 108-1 through 108-495 → .31

For Airplanes 108-496 and up → .50
