SERVICE BULLETIN

TITLE: Inspection of Stabilizer Leading Edge
Attachment

BULLETIN NO. 254

MODELS AFFECTED: 108 (Voyager and Flying Station
Wagon). Serial 108-1 through 108-
3500, Inclusive

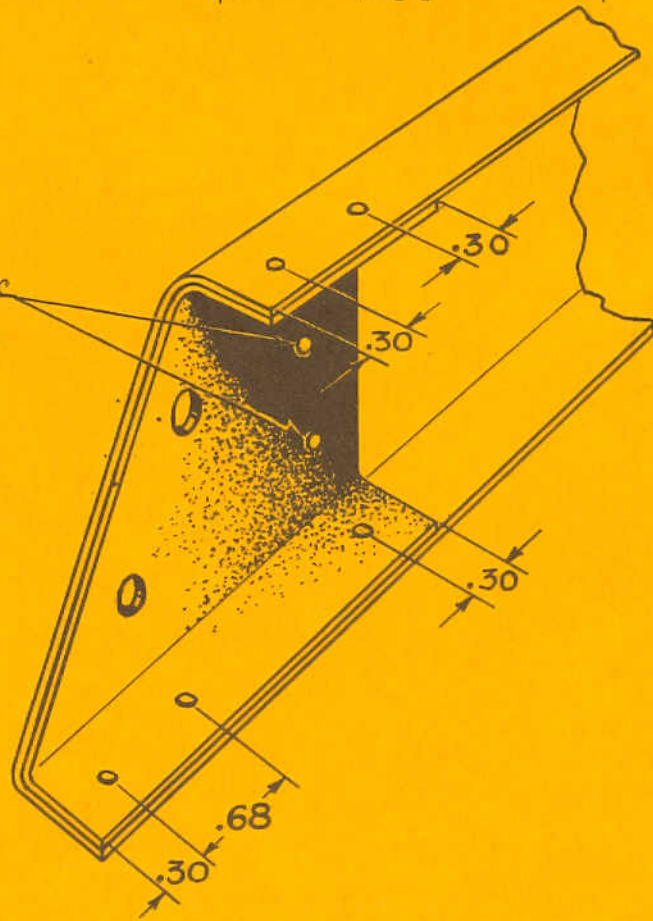
To determine whether or not fatigue cracks have developed in the fitting that attaches the horizontal stabilizer to the fin, it is recommended that all airplanes in the above category be inspected at this point. It is further recommended that this inspection be made after each 100 hours of operation.

Locate two rivets
through web to clear
crack

1. Remove the horizontal stabilizer forward attaching bolts and drop the leading edge to insure accessibility.
2. Drill a 1/16" stop-hole at each end of the crack to prevent spreading.
3. Fabricate and attach reinforcing channel to the stabilizer fitting as shown in the following sketch.

1 Piece 24ST Aluminum Sheet - .040 - 2" x 3"
7 - AN442-AD5 Rivets
