IMPORTANT - This is **NOT** an official Federal Aviation Administration list of Airworthiness Directives. See your Licensed Airframe and Powerplant Mechanic who also holds an Inspection Authorization for a complete up to date list of Airworthiness Directives.

This list is in three parts - Part 1 are AD's for the Stinson, Part 2 are AD's for the Franklin engine, Part 3 are AD's for Stinson Propellers, Part 4 are AD's for MARVEL-SCHEBLER Carburetor.

Part 1 - Stinson Airplane

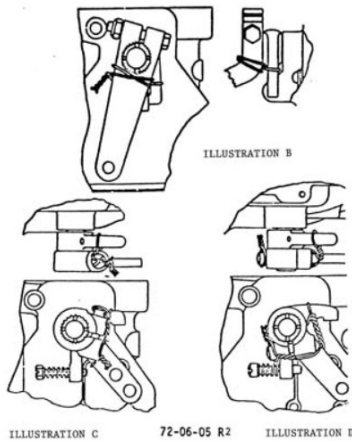
(2) Inspect the throttle arm on Marvel Schebler MA-3, MA-3A, MA-3PA, MA3-SPA, and MA-4SPA carburetors to determine whether it has a spotfaced or milled flat for the head of the clamping screw. Replace any arm having a milled flat with one having a spotfaced flat. If not already installed, install a Marvel Schebler P/N A15-493 clamping screw (No. 10-24 x 5/8 slotted drilled fillister head) in the throttle arm. Torque the clamping screw to 20-28 in.-lb. and inspect the slot in the end of the arm for clearance. If the slot has closed so that no clearance remains, replace the arm and retorque to the above specifications. After the specified torque is established safety wire the throttle arm and clamping screw to the throttle stop as shown in Illustration A.

(1) Inspect the throttle arm to verify that it is bottomed against the shoulder on the throttle stop and positioned so that full throttle travel is obtained, and if not, loosen clamping screw and reposition arm and/or re-rig control system in accordance with airplane manufacturers' maintenance instructions to obtain these conditions.
