SERVICE BULLETIN

TITLE Replacement of Elevator Cable Fairlead

BULLETIN NO. 230

MODELS AFFECTED: 108 (Voyager 150)
Serial 108-1 through 108-50

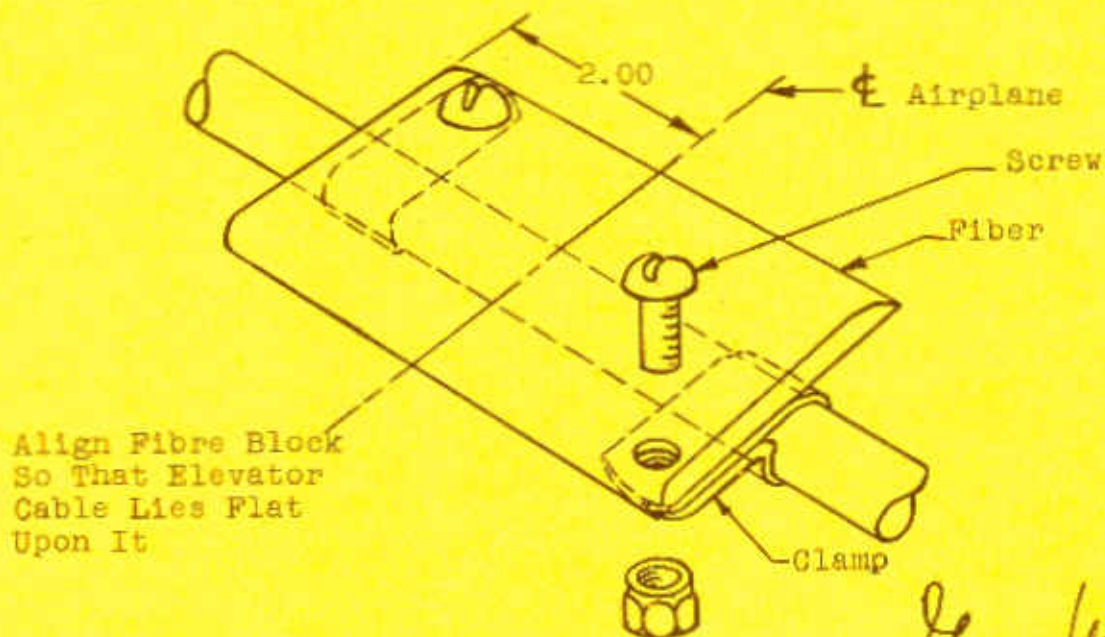
Service has revealed that the lower elevator cable fairlead installed on a fuselage tube at station 100.00 (approximately 14" aft of rear cabin curtain) is of insufficient durability and should be replaced with a heavier hard red fibre block as shown on Figure 1.

Access to the fairlead may be gained by removing the rear seat hammocks and opening the rear cabin curtain.

Remove the present fairlead by grinding off the heads of the drive screws with which it is attached. Hammer these screws flush with the tube surface after removal of the fairlead.

1 - 108-3041000-26	Fibre
2 - AN-526-1032-8	Screw
2 - AN-365-1032	Nut
2 - AN-742-8	Clamp
